Intel[®] Xeon[®] Processor E3-1200 v2 Product Family

Specification Update

August 2015

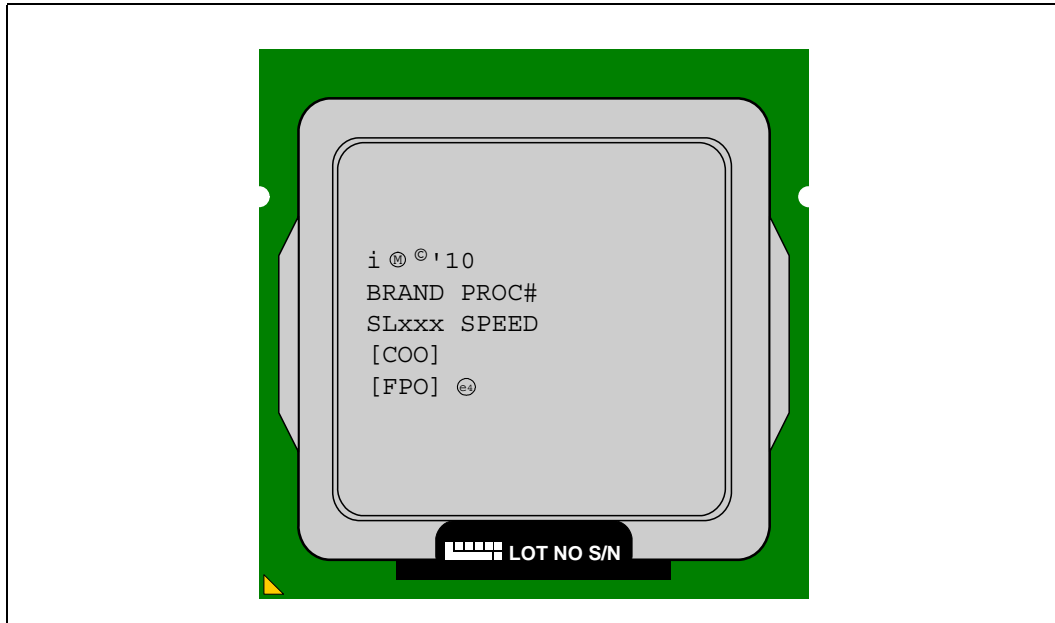
The processor stepping can be identified by the following component markings.

Figure 1. Processor Production Top-side Markings (Example)
